**DRAFT**  
**GEOTECHNICAL REPORT**  
**TESTON ROAD IMPROVEMENTS**  
**250 M WEST OF PINE VALLEY DRIVE TO**  
**KLEINBURG SUMMIT WAY**  
**CITY OF VAUGHAN, ONTARIO**

File No. 1-20-0160  
February 08, 2022  
©Terraprobe

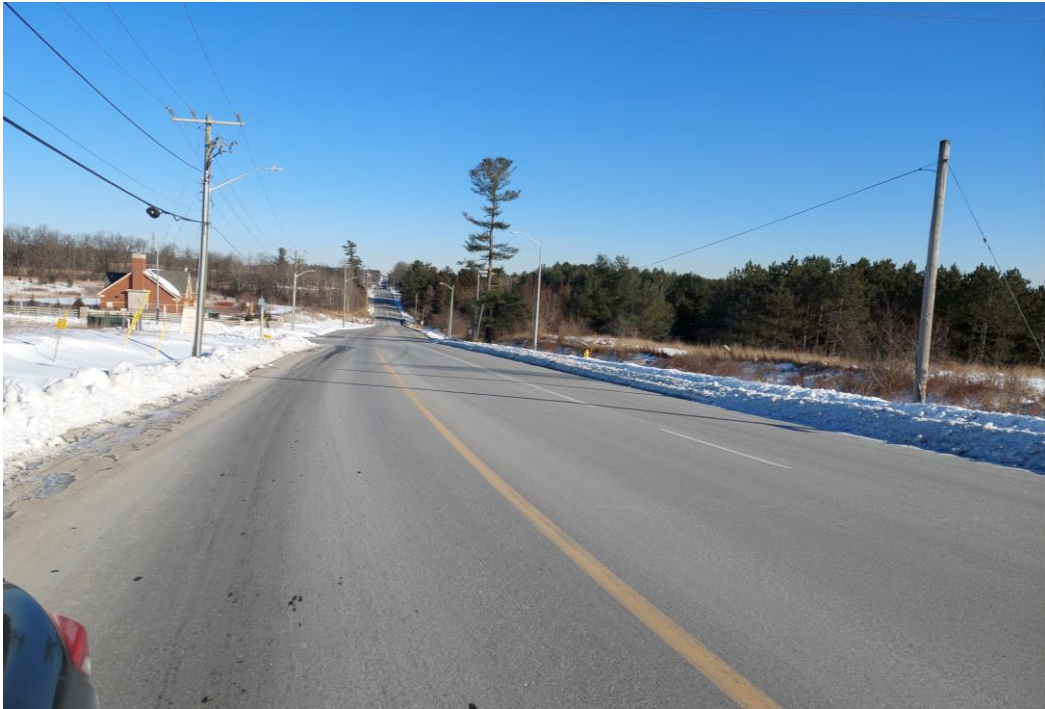
Photo 1: Teston Road at Sta. 1+000, Looking East

A visual pavement condition evaluation was carried out in January, 2022 in accordance with the Ministry of Transportation of Ontario, (MTO) *Manual for Condition Rating of Flexible Pavements Distress Manifestations, SP-024*. The Pavement Condition Evaluation Forms are included in Appendix D, and site photographs are presented in Figures 4 to 7.

Section	Overall Condition	General Distresses
Teston Road Sta. 1+000 to Sta. 1+180	PCR* = 95 RCR** = 9.5 Excellent	<ul style="list-style-type: none"> <li>▪ Few very slight ravelling and coarse aggregate loss; and</li> <li>▪ Few very slight random/map cracking.</li> </ul>
Teston Road Sta. 1+180 to Sta. 2+720	PCR* = 65 RCR** = 6.5 Good	<ul style="list-style-type: none"> <li>▪ Frequent slight ravelling and coarse aggregate loss;</li> <li>▪ Intermittent slight wheel track rutting;</li> <li>▪ Few slight distortion;</li> <li>▪ Few slight single and multiple longitudinal wheel track cracking;</li> <li>▪ Intermittent moderate single and multiple centre line cracking;</li> <li>▪ Intermittent slight alligator centre line cracking;</li> <li>▪ Frequent slight single and multiple pavement edge cracking;</li> <li>▪ Intermittent slight alligator pavement edge cracking;</li> <li>▪ Few slight half, full and multiple transverse cracking;</li> <li>▪ Few slight alligator transverse cracking; and</li> <li>▪ Intermittent slight random/map cracking.</li> </ul>

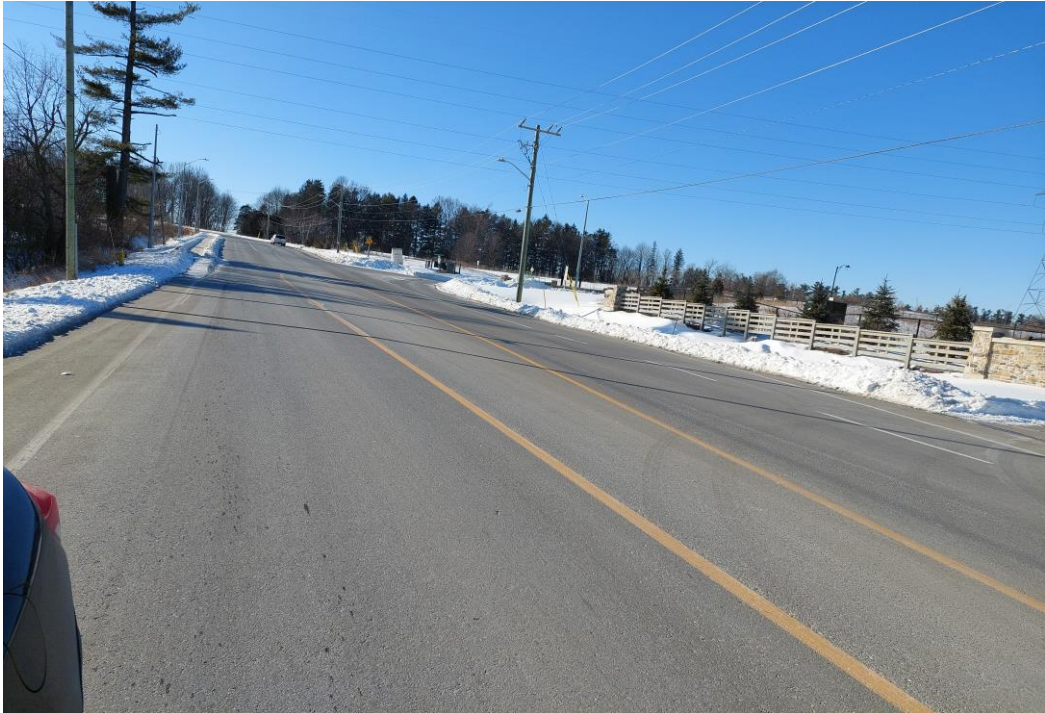
Photo 2: Teston Road at Sta. 1+120, Looking West

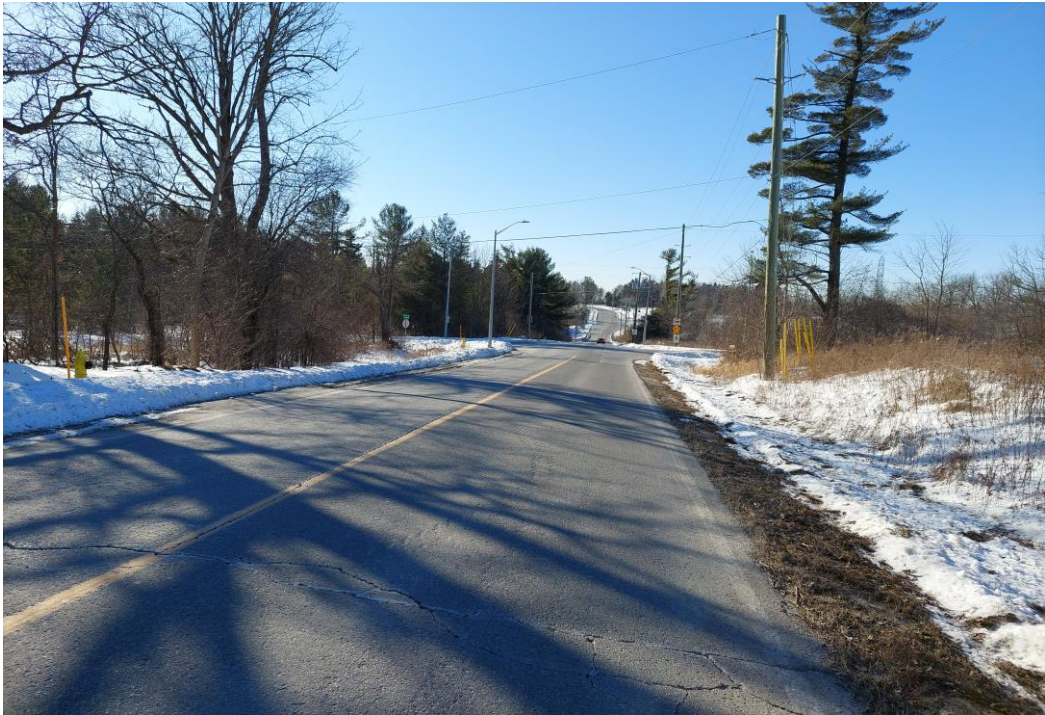
Photo 3: Teston Road at Sta. 1+450, Looking West

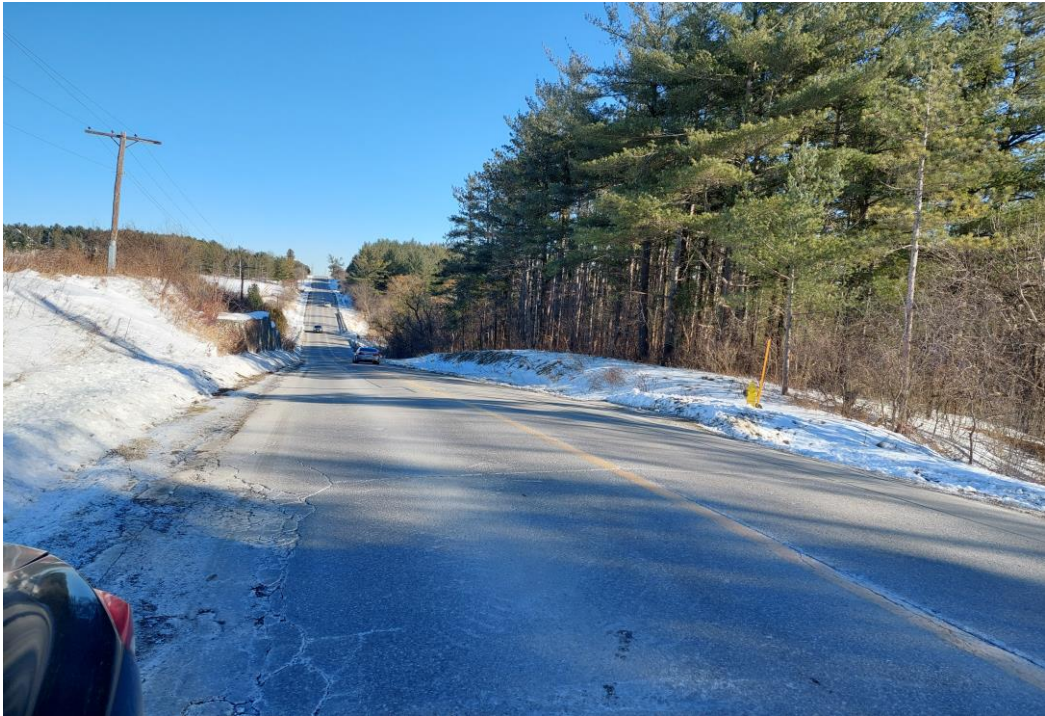
Photo 4: Teston Road at Sta. 2+050, Looking East

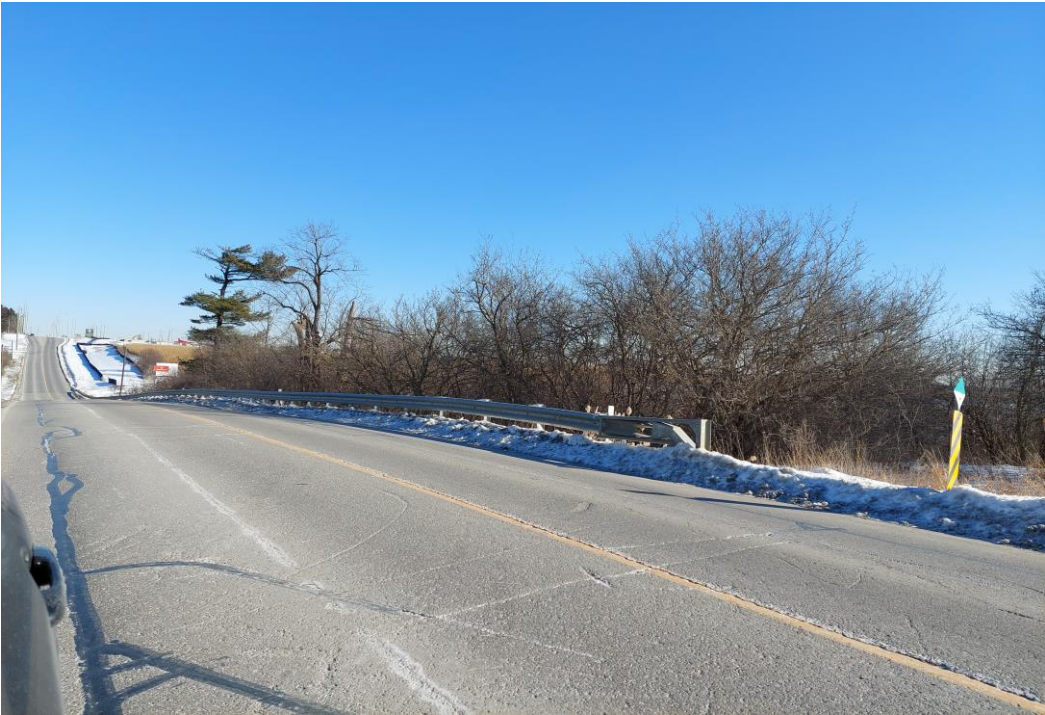
Photo 5: Teston Road at Sta. 2+600, Looking East

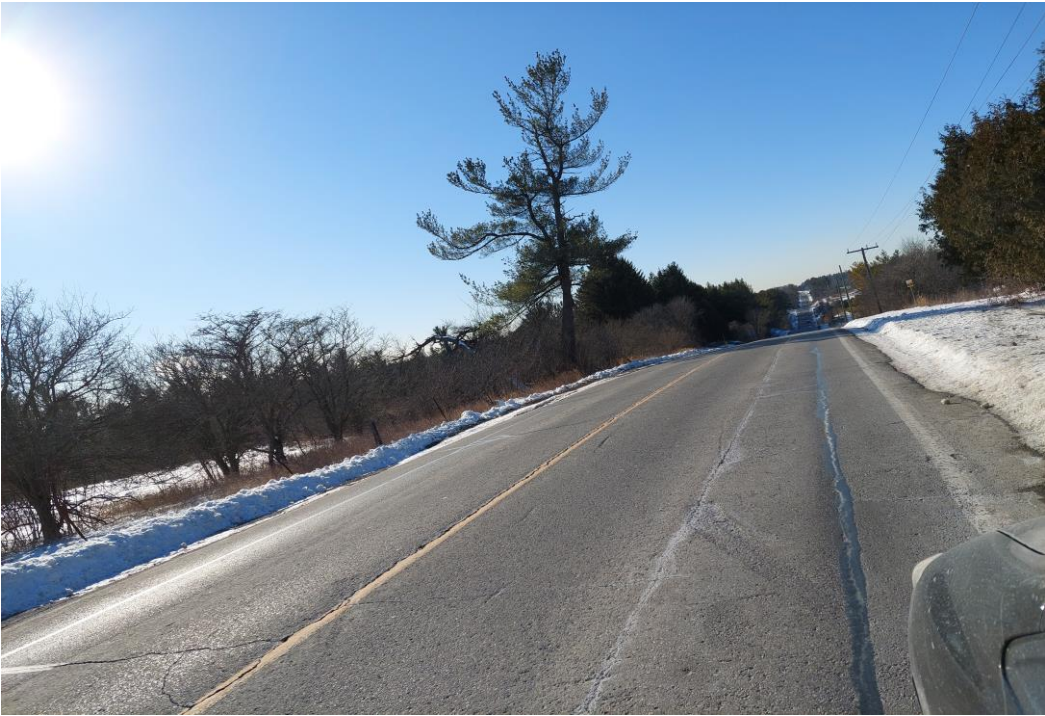
Photo 6: Teston Road at Sta. 2+600, Looking West

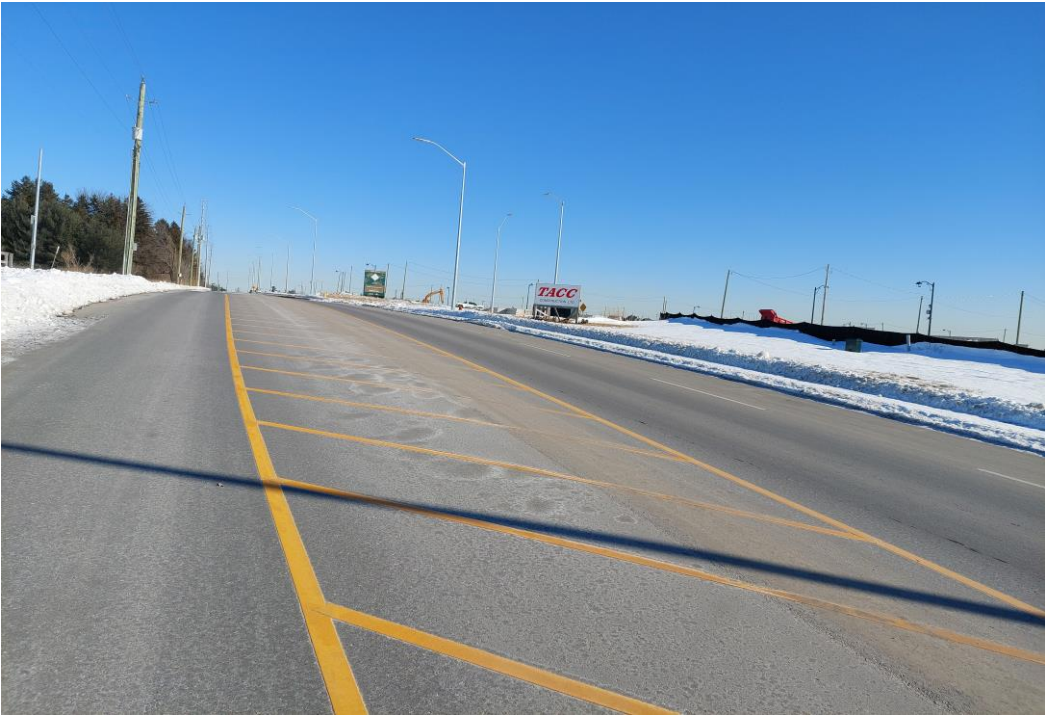
Photo 7: Teston Road at Sta. 2+950, Looking East

Based on our visual pavement condition evaluation and data obtained from field investigations, it is noted that Teston Road's pavement has been recently rehabilitated towards the east project limit, i.e., between Sta. 2+720 and Sta. 3+175. Provided that no grade lowering is required in this section, we recommend 50 mm partial depth milling and repaving with a 50 mm thick HL3 surface course. The existing pavement structure for this section is adequate for the 2031 Horizon Year and no rehabilitation is warranted.

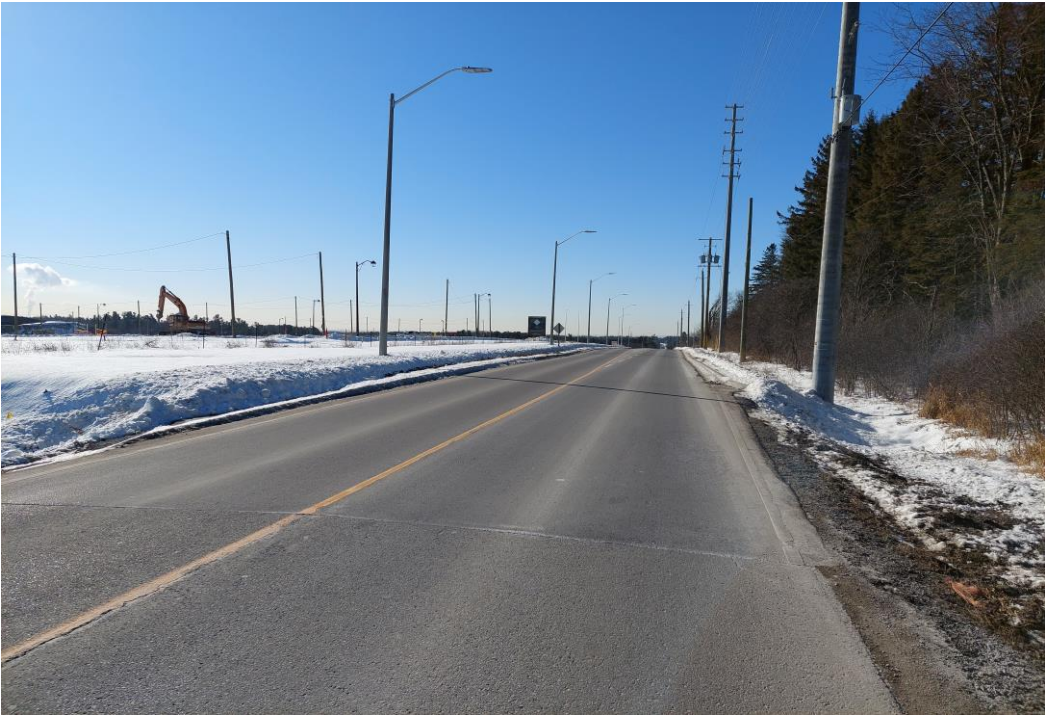
Photo 8: Teston Road at Sta. 3+175, Looking West

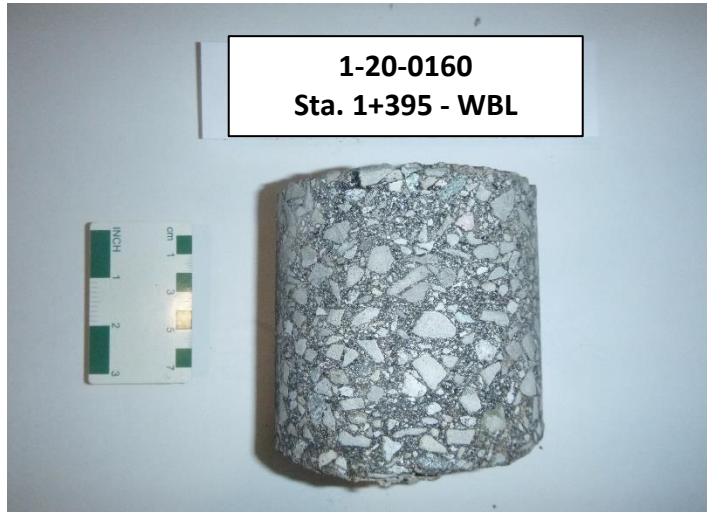
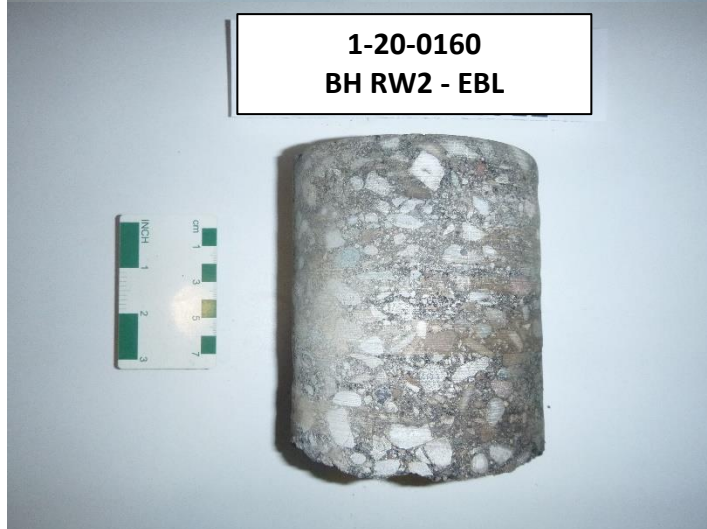
Sta. 1+395  
WBL

Lift Type	Thickness (mm)
HL3	50
HL3	60
Total	110
